NBS TECHNICAL NOTE 807

Building Performance in the 1972 Managua Earthquake

Following the Managua, Nicaragua, earthquake of December 23, 1972, a team of engineers representing the U.S. Department of Commerce's National Bureau of Standards (NBS) and the National Academy of Engineering (NAE) performed field investigations in Managua, Nicaragua, from December 26, 1972, to January 4, 1973. The objectives were to assist the Nicaraguan government in surveying major buildings to determine whether each was suitable for emergency use, repairable, or appropriate for clearance. The team also viewed the patterns of successful performance and damage to identify needs for improvements in building practices for mitigation of earthquake hazards and opportunities for more detailed investigations which could provide information for future improvements in practices.

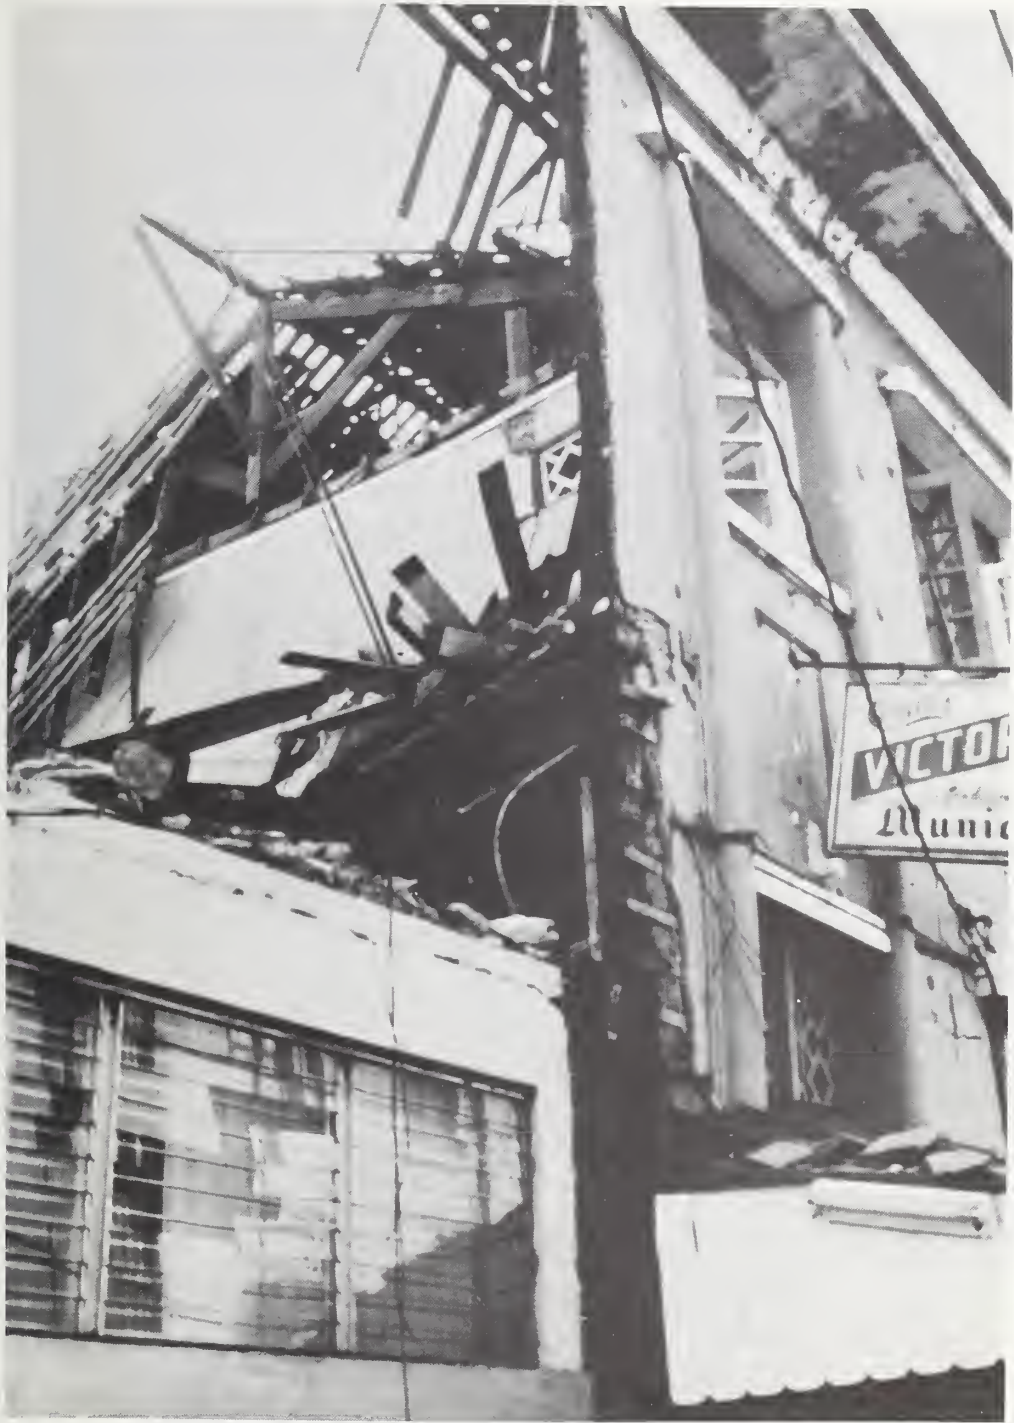
Figure 15 Taquezal construction where the substantial appearance after plastering and painting is belied by the resistance.

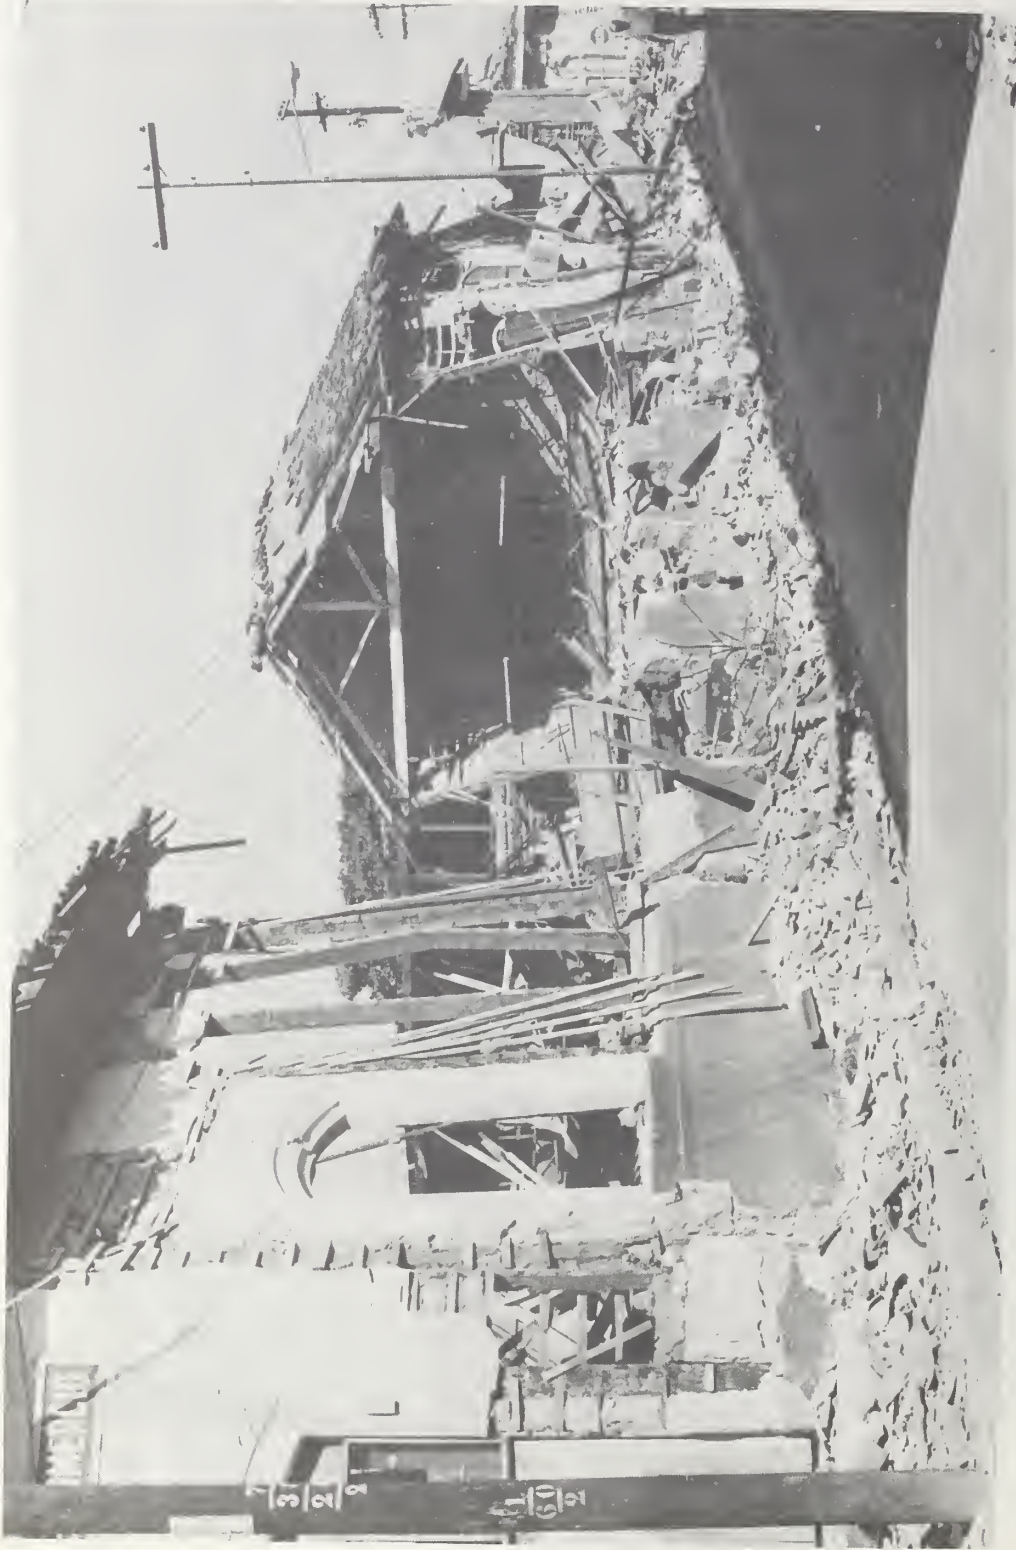
Much of the older residential and commercial construction in Managua was of the type called "taquezal." This is timber framed adobe construction made up of wood posts approximately 4 in square, spaced on approximately 2 ft centers, and connected horizontally by wooden slats which were about 1/2 in by 2 in and spaced at 8 in vertically. The space between the wooden slats was packed with mud, figure 14. These structures usually had timber framed floors and roofs with the roofs often covered by clay tile. The exterior surface would be plastered and painted, figure 15, to form a building of substantial appearance. However, these buildings were inherently quite weak, and heavy enough to generate large lateral forces under ground shaking. In addition, the timber framing was frequently weakened by termites. Over much of the Managua area, these buildings collapsed, figure 16; most of the deaths were suffered in this type of building.

Figure 16 View of the taquezal areas of Managua which were largely collapsed.

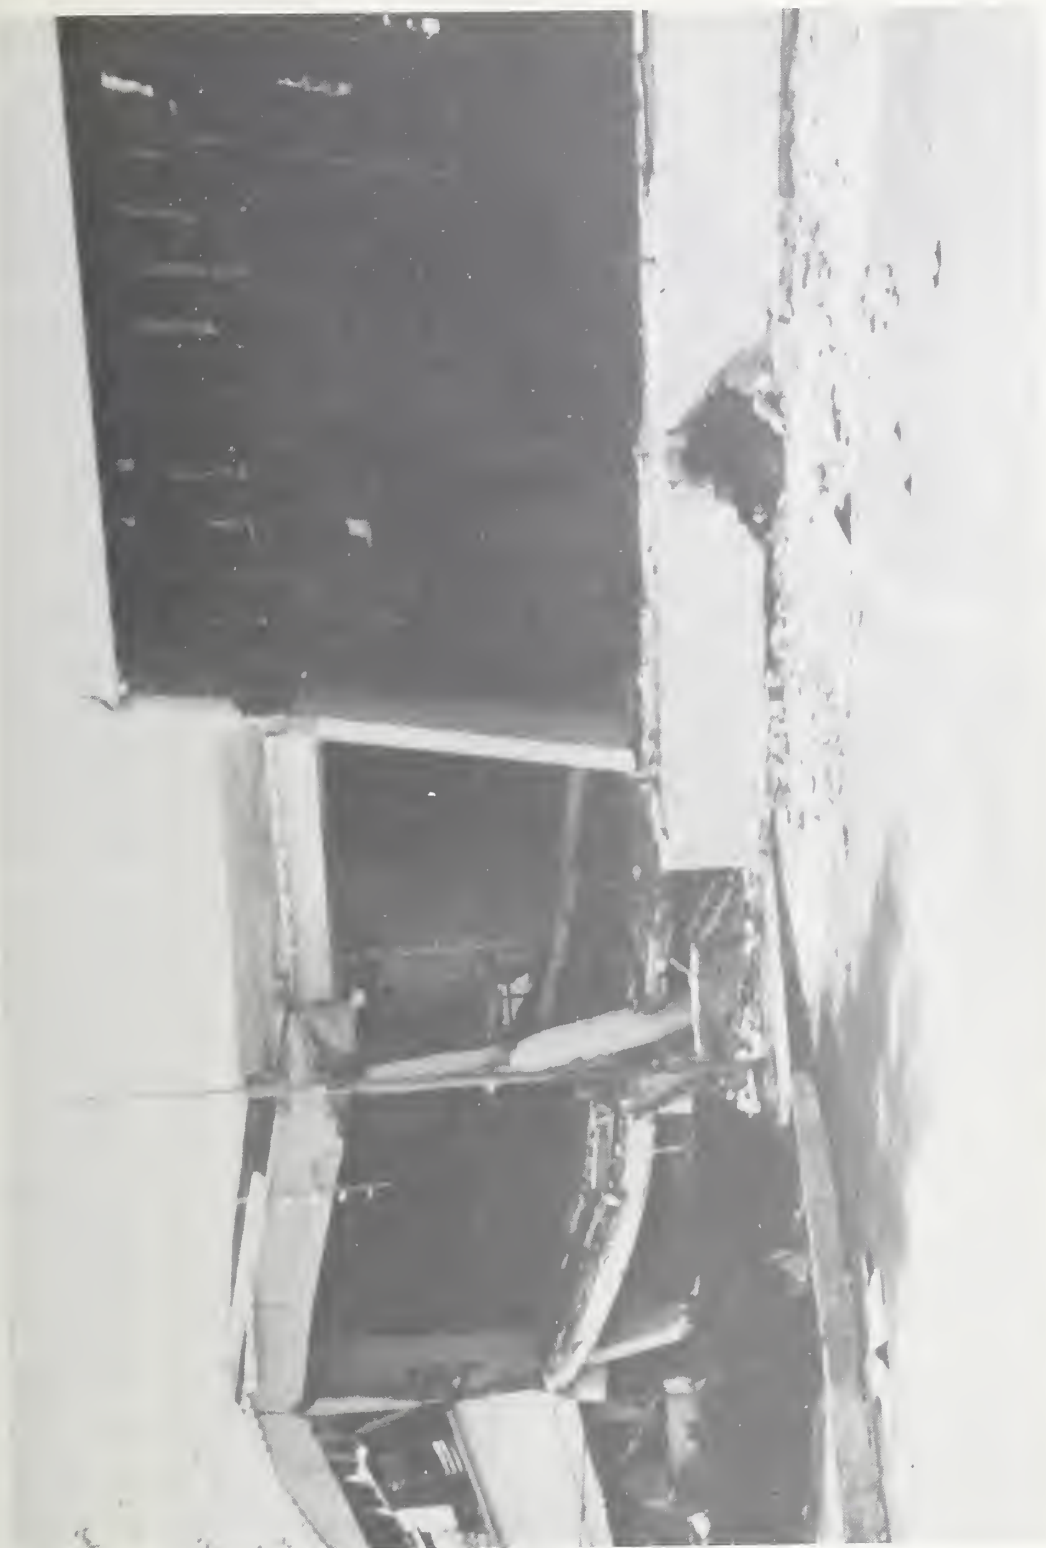
Figure 17 The Fire Station collapsed upon fire equipment.

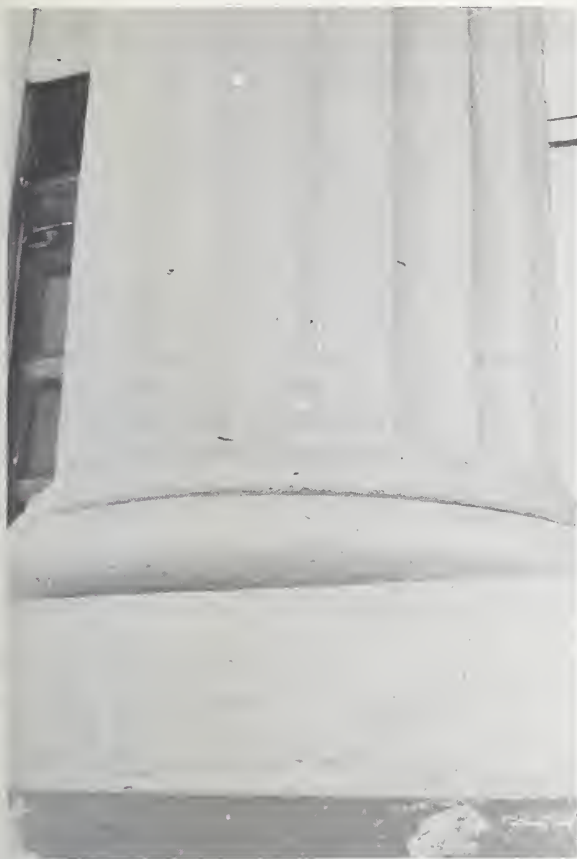
Figure 3-1 Lightly cracked columns in facade, Palacio Nacional.

None of these damages appear to have severely limited the safety of the structure. However, these damages should be repaired so that the structural resistance is returned to its original level and a careful inspection should be conducted to determine whether other damages have occurred.

The structure may be cleaned of broken glass and concrete which endanger occupants and returned to function while the major repairs are conducted.

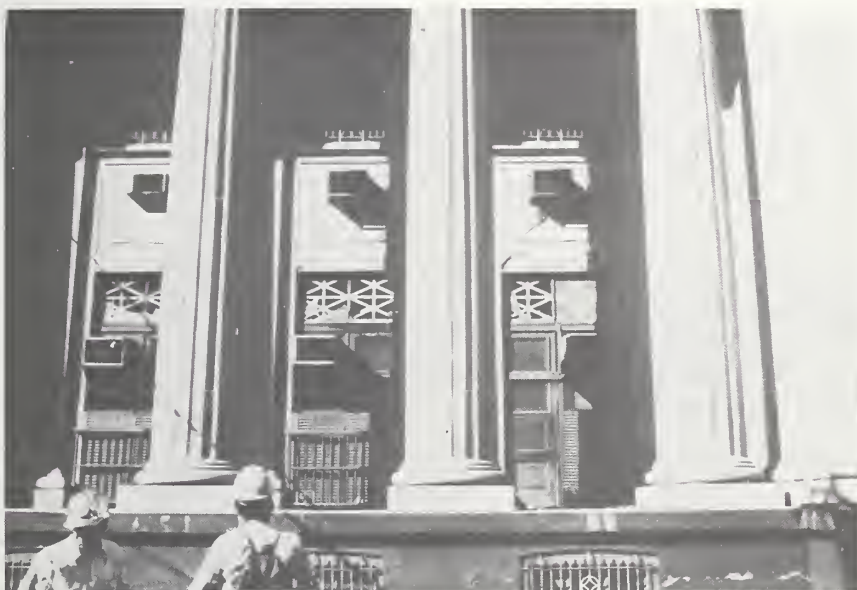
Figure 3-2 Cracking in panels between columns where pierced for air conditions, Palacio Nacional.

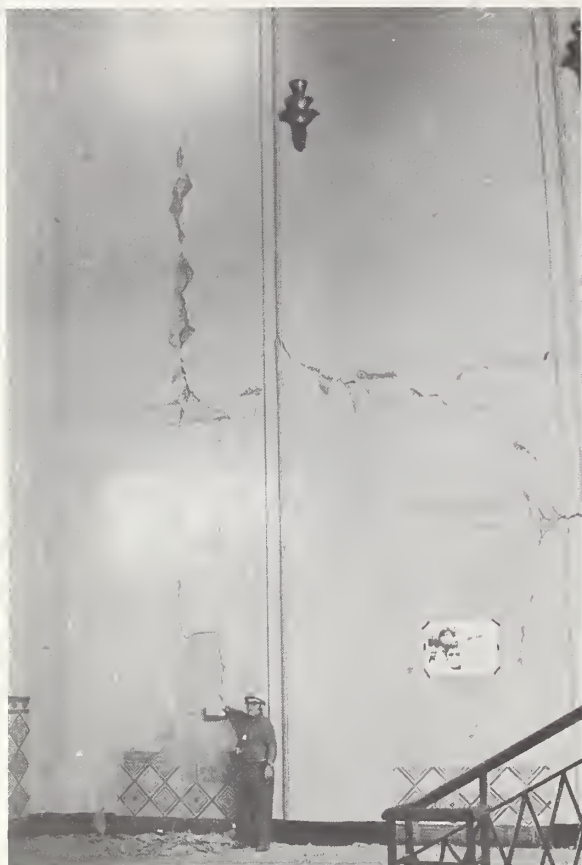
Figure 3-3 Cracking of wall and columns at north entrance to the Palacio Nacional.

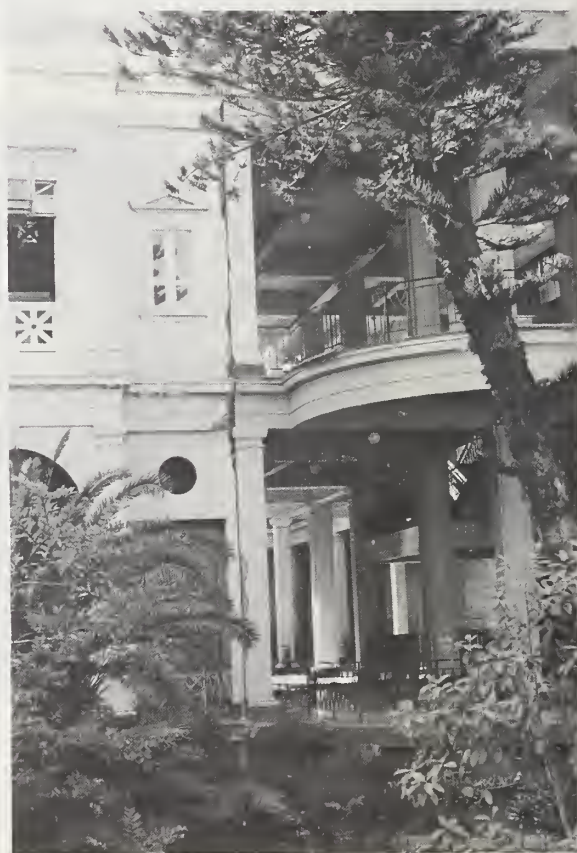
north wing, central building and south wing at their zones of contact, figure 3-4.

Figure 3-4 Pounding between central building and north wing, Palacio Nacional.

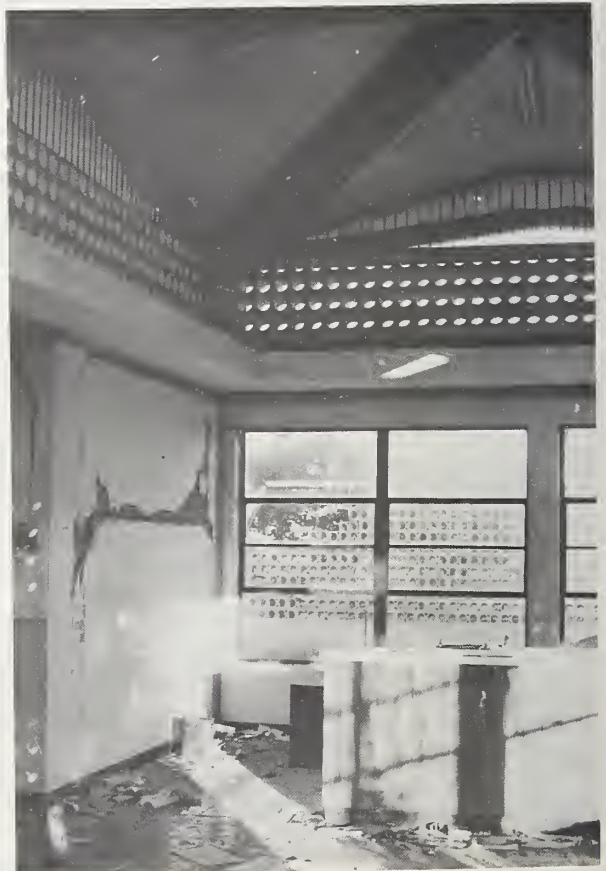
Figure 4-3 Damaged canopy columns at change of canopy elevation, Mercado Periferico Oriental.

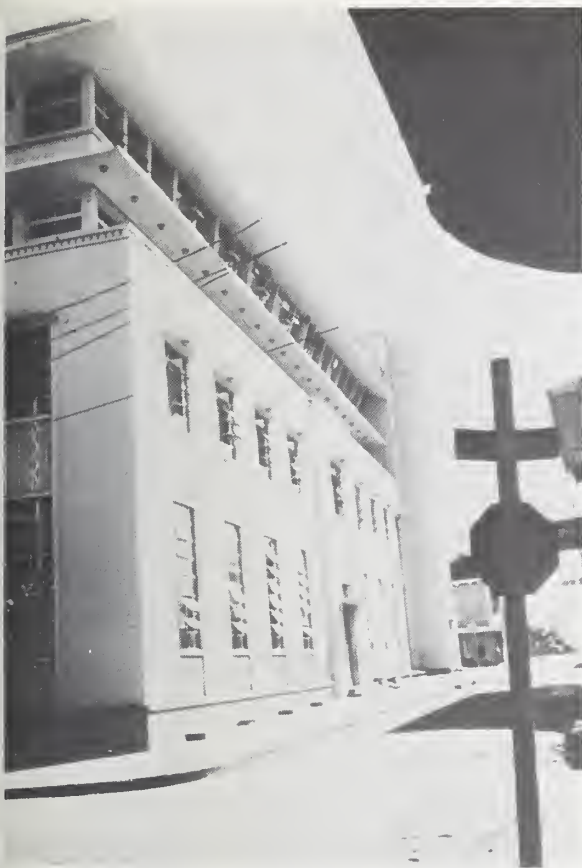
Figure 5-3 Side of the Palacio de Comunicaciones, note the tottering fourth floor walls and roof.

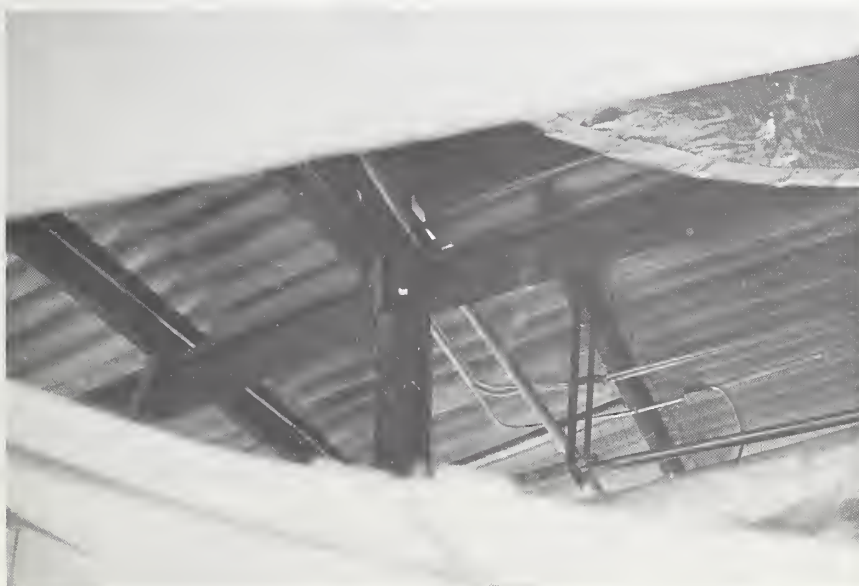
Figure 5-4 Tube column split by pulling of roof framing, Palacio de Comunicaciones.

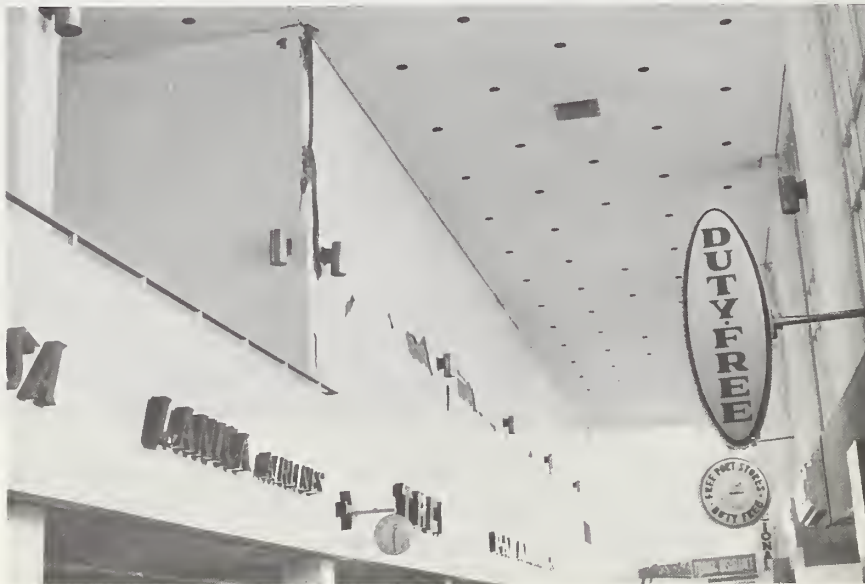
Figure 13-3 Overlayed curtain wall cracked at anchorage to frame, Aeropuerto Internacional.

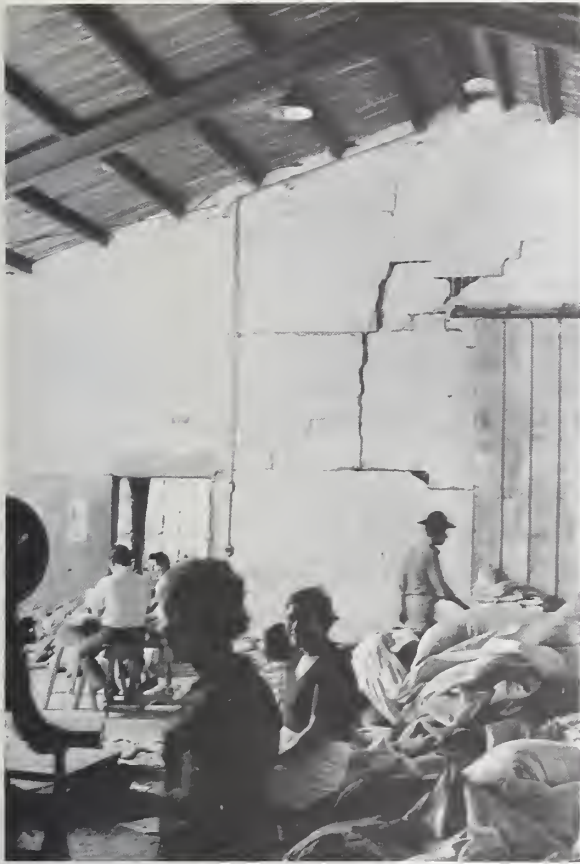
Figure 16-3 Hazardous partition in an undamaged steel industrial building, INCEI shed.

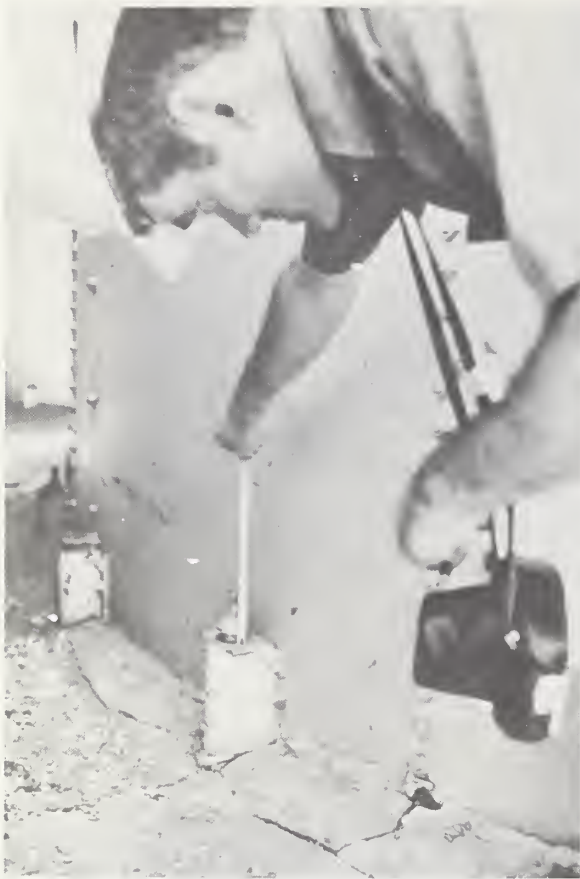
Figure 16-5 Anchor bolts lifted at base of INCEI elevators.

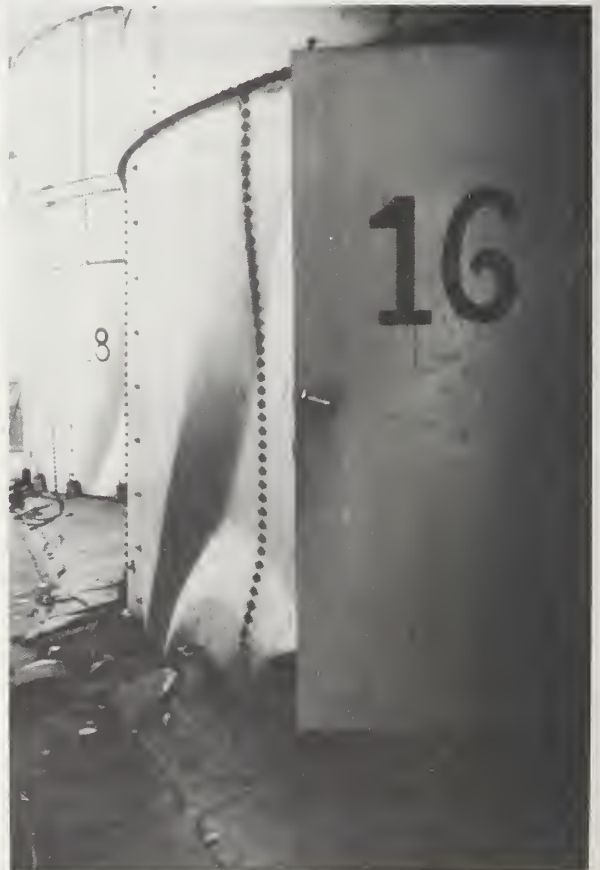
Figure 16-6 Compressive buckling at base of INCEI elevators.

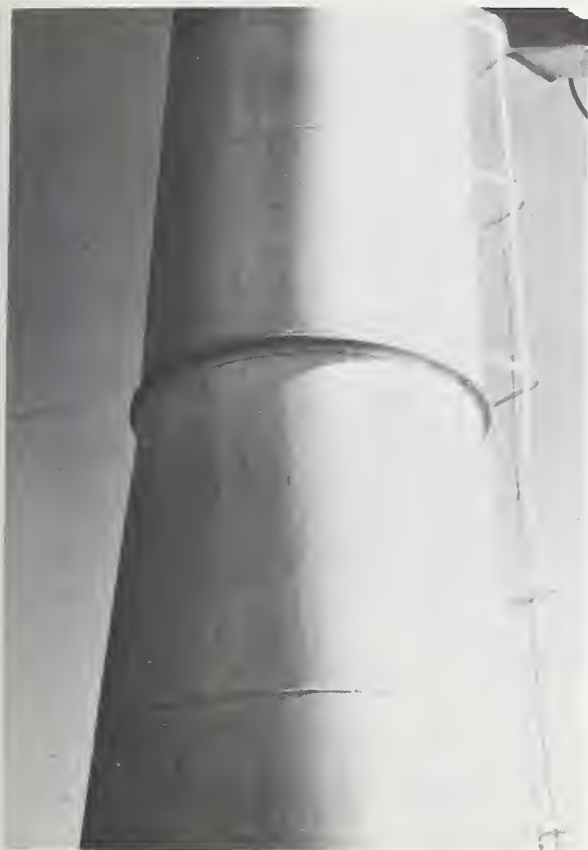
Figure 22-3 Cracked weld in stack,
Planta Electrica ENALUF.

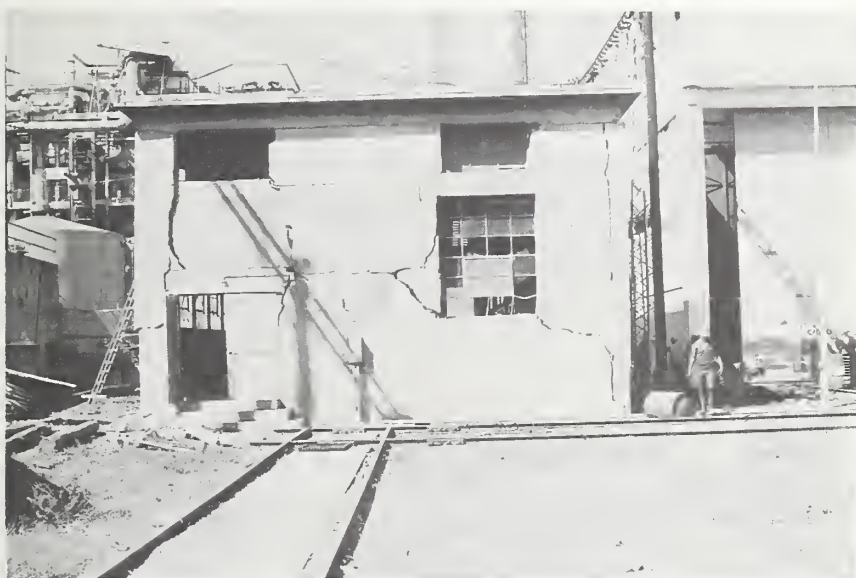
very severe damage; fortunately, the critical medical supplies stored in a warehouse behind the hospital were on steel shelving, figure 55-8, which supported the building when its walls fell and columns sheared and kept these supplies available for use following the earthquake. Radio communications were dependent on a very feeble building, figure 62-1; however, it was far enough south of town that the collapse was incipient rather than actual. Similarly, the vital switch gear at the power generation plant, figure 22-4, were located in a weak masonry building with a very heavy roof; the building was close to collapse.

Figure 22-4 Severely damaged concrete block bearing
walls of switch gear house at Planta
Electrica ENALUF.

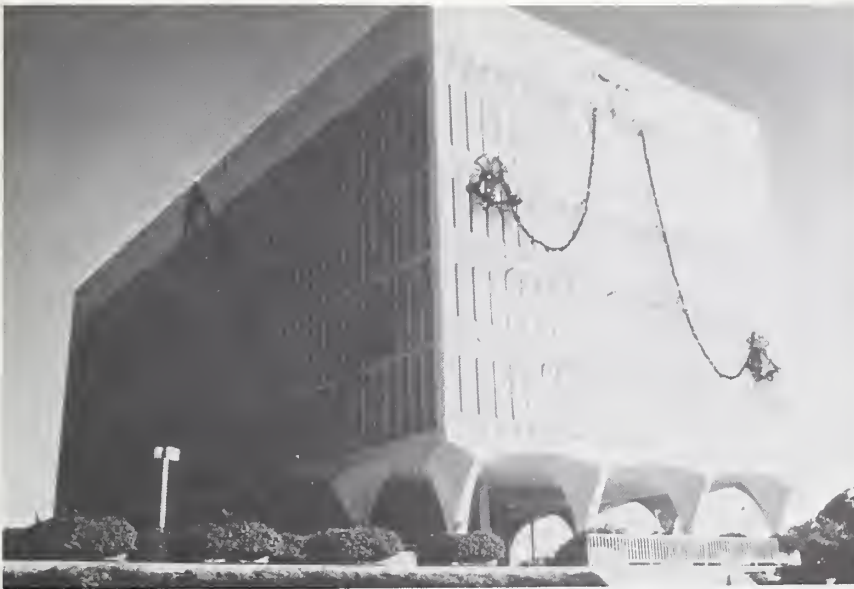
This is a reinforced concrete building with basement, ground floor and six additional floors with a reinforced concrete frame braced by reinforced concrete shear walls around the central core of the building, figure 23-1. In general the exterior of the building and the interior space dividers are in excellent condition, figure 23-2. The shear walls functioned effectively in reducing the earthquake deformations of the building to a level producing little cosmetic damage. However, a substantial amount of cracking was found in the shear wall structure. On the ground floor, local crushing of the shear wall was observed at a splice zone near the floor level where the wall was weakened by a telephone chase, figure 23-3, and at the ceiling level adjacent to a penetration in the shear wall for a duct, figure 23-4. Additional cracking in the shear wall was noted at the basement level. Light cracking in the shear wall was noted from the third through the fifth floors of the building, figure 23-5. The absence of notable cracking on the first and second floors, perhaps was due to an unintended bracing action of the decorative exterior arches. It was noted that the counter weights for the elevators had been displaced by the shock, and other minor cosmetic damage was visible in the building.

Figure 23-1 Shear wall-frame building with little exterior damage, Edificio Administrativo ENALUF.

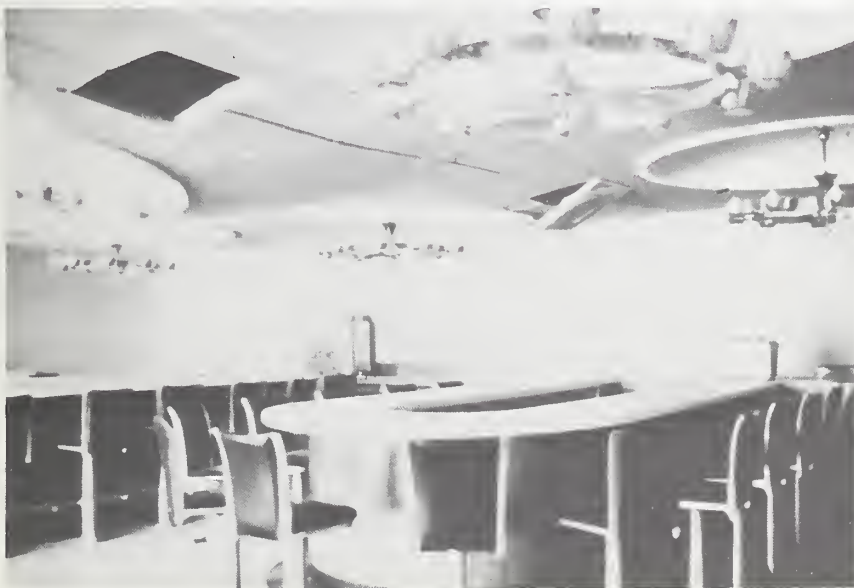
Figure 23-2 Relatively light interior nonstructural damage, Edificio Administrativo ENALUF.

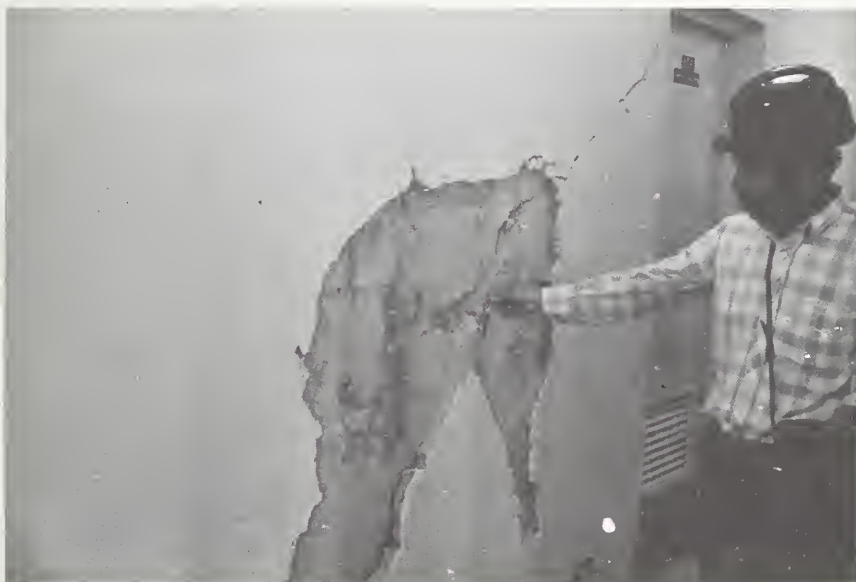
figure 23-4, and for a telephone chase, figure 23-3. On the upper floors there were many diagonal cracks in the shear wall, figure 23-5. The 17 story Banco de American Building also looked quite sound from the outside and showed little nonstructural damage on the inside, figure 54-2. However, many tie beams connecting the four shear wall towers at the corners of the core broke in shear at their mid-span where they were penetrated for ducts, figure 54-1.

Figure 23-5 Cracking in shear wall on third floor, Edificio Administrativo ENALUF.

Since the damages to the shear wall represent a partial failure of the structure, a detailed engineering inspection and repairs of the damages are required before the structure is returned to service.

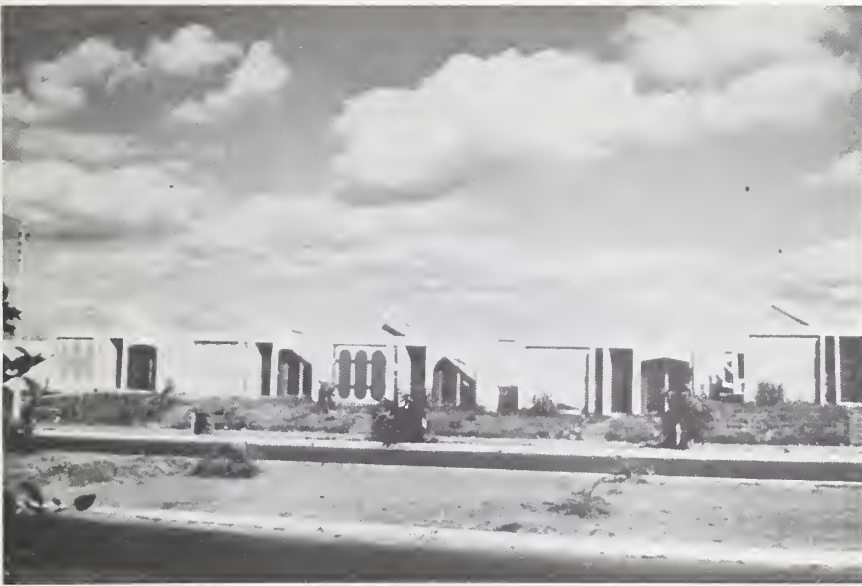
The houses of the subdivision are single and duplex units with cast-in-place reinforced concrete walls and prefabricated roof panels in the form of a channel, figures 24-1 and 24-2. The dwelling units are approximately 20 ft wide by 40 ft deep. The prefabricated roof panels bear on the precast concrete walls which are about 4 in wide. The concrete roof slabs are approximately 3 in thick with the flanges of the channel approximately 12 in high; the panels are about 8 ft wide and 22 ft long. Metal pads at the four corners of the roof slabs are used for connection to similar pads embedded in the walls. The connection is by a 3/16 in fillet weld about 1 in long, figure 24-3. In single houses, the roof slabs overhang the walls at each side by about 8 in. In the duplex units, one wall supports two panels so that the zone of contact is limited to about 2 in and welds may have been omitted.

In most of the dwelling units, the roof slabs were observed to have broken loose from the walls and to have translated, sometimes enough to allow the roof slab to fall into the dwelling unit, particularly for the duplex units which have very little overlap of the roof slab on the wall, figure 24-4. The degree of damage to the walls themselves appears quite small; there were small cracks in the walls near the apertures and sometimes cracking where the connecting pads were anchored in the wall slabs. Most of these buildings appear to be repairable. In the repairs, attention should be given to achieving a stronger connection between the roof slab and the walls to prevent repetition of this damage in a future earthquake.

Figure 24-1 The tilted precast roof channels have slid off walls, Bello Horizonte.

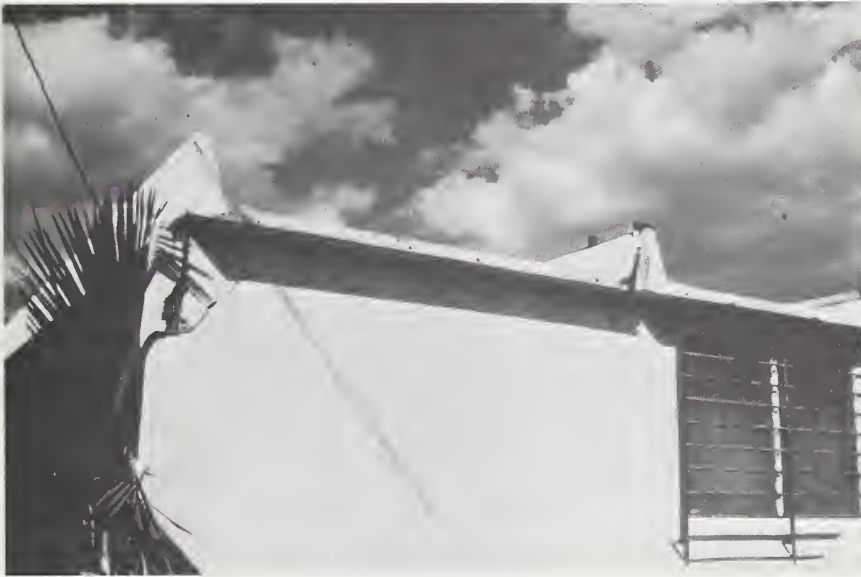
Figure 24-2 Cracking in walls at attachment of roof channel, Bello Horizonte.

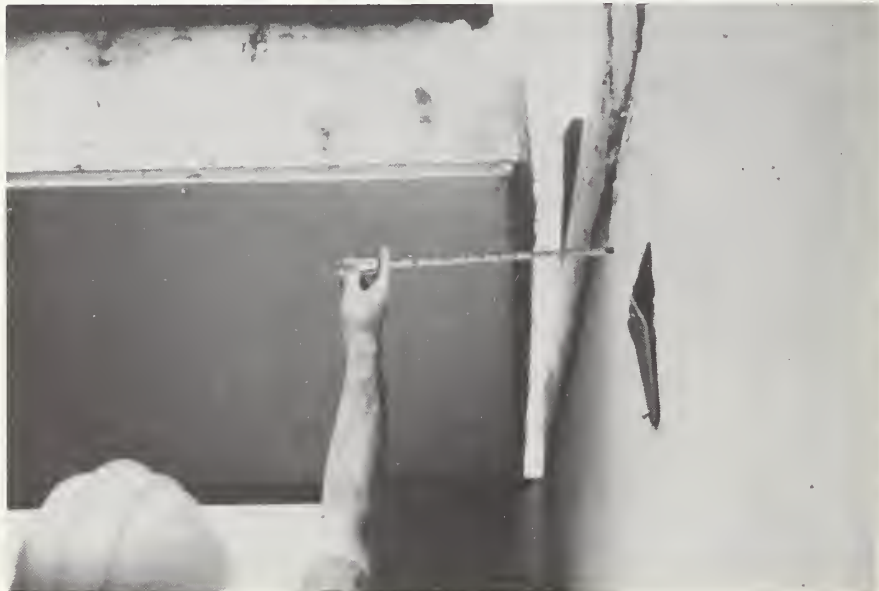
The generally poor performance of taquezal housing which led to large losses of life and property has been previously discussed. Also some modern houses, using materials such as prestressed concrete, reinforced concrete, and masonry with precast members and prefabrication techniques as well as other so called modern technologies, were designed or constructed without adequate attention to the potential earthquake forces and performed poorly. A housing development under construction with reinforced concrete frames infilled by concrete block walls, figure 21, showed wall failures because of inadequate attachment to the frames. Some more expensive modern houses also collapsed, figure 22. A development of cast-in-place concrete houses, with prestressed, precast channel roof elements approximately 8 ft wide by 20 ft long, failed due to inadequate attachment of the roofs to the walls, figure 24-1. At best the precast channels were connected only at the four corners by an inch or two of small fillet weld, figure 24-3. On duplex units where two roof channels bore on a party wall, it apparently was considered inconvenient to make any connection whatsoever, figure 24-4.

Figure 24-4 Unfastened roof channel in duplex unit, Bello Horizonte.

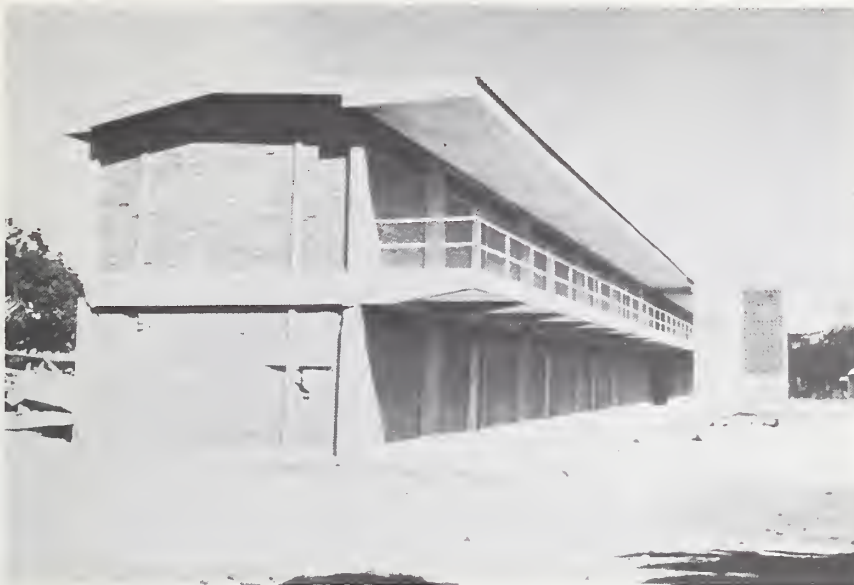
Figure 35-2 New building of reinforced concrete and masonry construction, Centro Escolar Simon Bolivar.

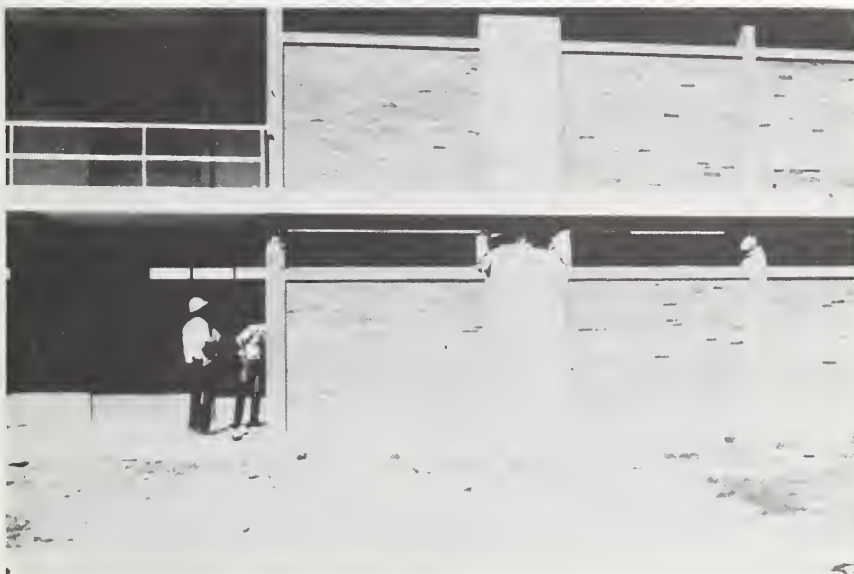
Figure 35-3 Sheared columns above infill wall, Centro Escolar Simon Bolivar.

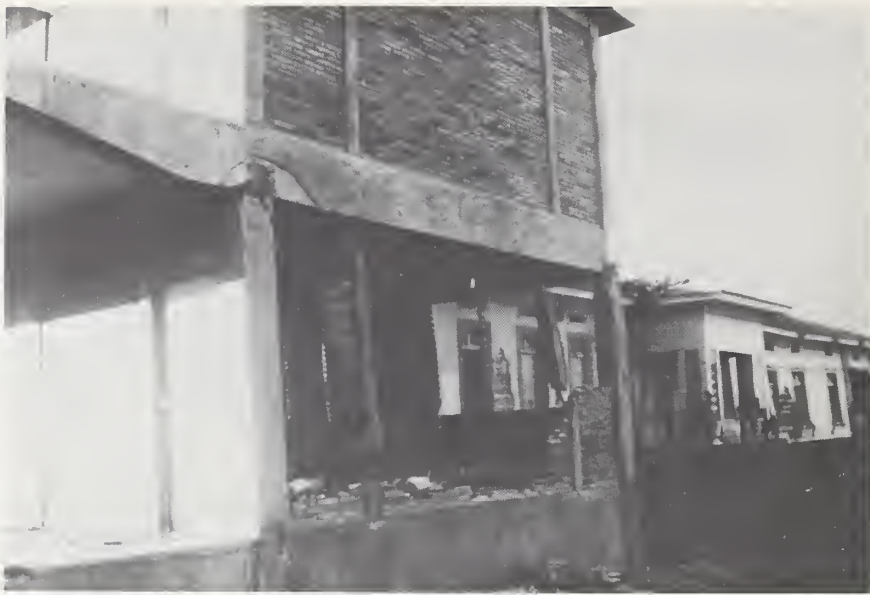
Figure 35-4 Fallen end wall and sheared columns, Centro Escolar Simon Bolivar.

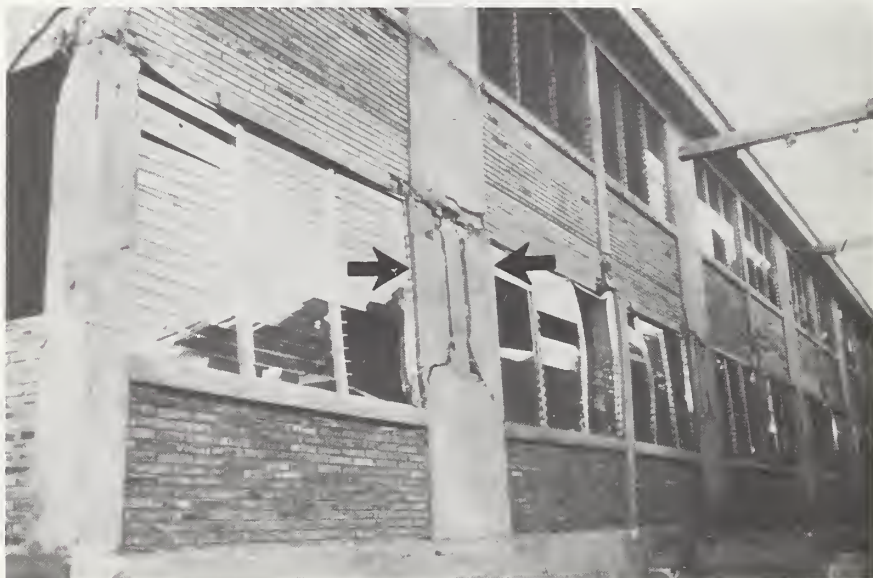
Figure 35-5 Arrows show masonry piers on either side of reinforced concrete columns were ineffective, Centro Escolar Simon Bolivar.

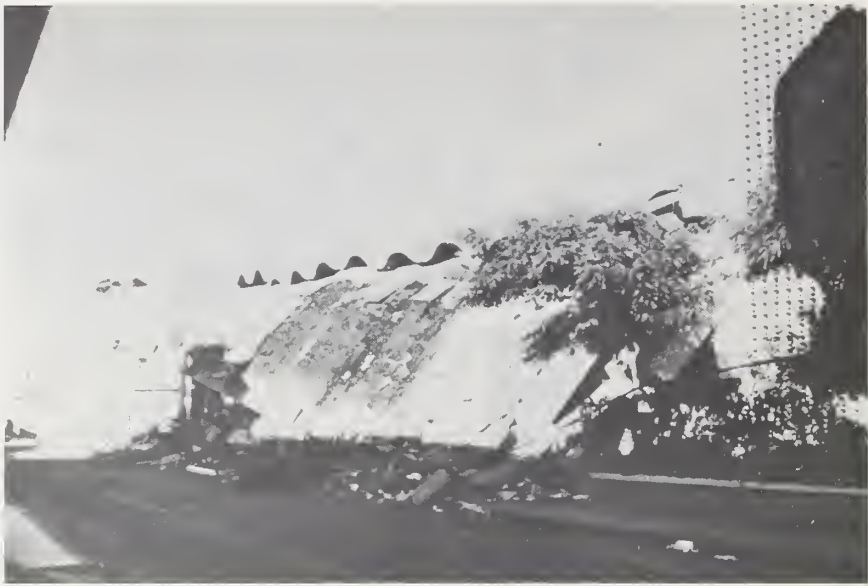
The top two stories of the west wing and the stair tower at its northern end are completely collapsed, very likely from progressive failure after the type of failure of the interior columns observed in the other two wings, figure 38-2 and 38-3. It was apparent that undeformed reinforcing steel had been used in the construction of this building which was completed in 1954.

Figure 38-3 Street view of the collapsed upper two stories of the west wing, Instituto Nacional Ramirez Goyena.

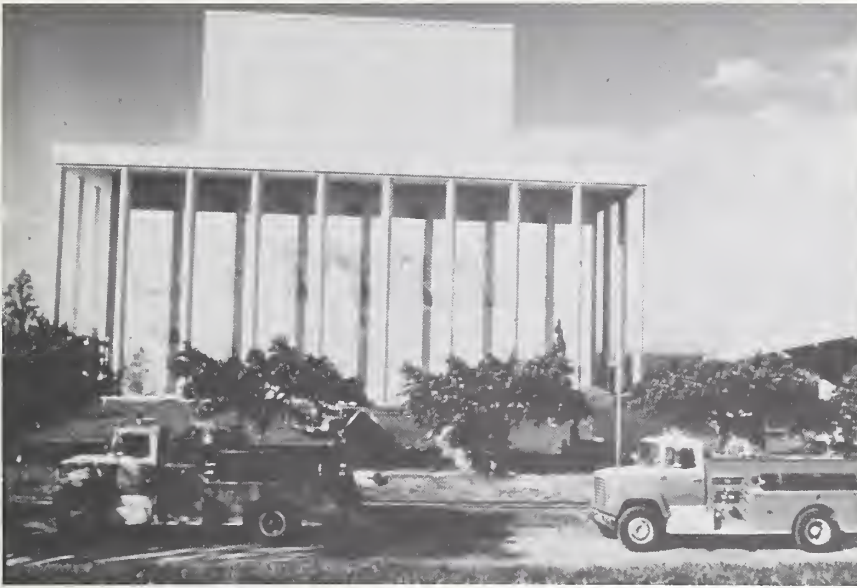
The only damages visible from the outside of the building involve the breaking of a few panes of glass and some damage to exterior masonry walls. The interior could not be carefully inspected because of the lack of electric illumination. There were some interior damages to the Chiltepe block and a few panels of the suspended ceiling had fallen, figure 41-3 and 41-4. However, there were no visible evidences of structural damage. A careful examination of the structure should be carried out as part of the repair program, but it appears that the structure will be ready for use following the minor cosmetic repairs.

Figure 41-1 South facade of theatre showing some loss of finish, Teatro Ruben Dario.

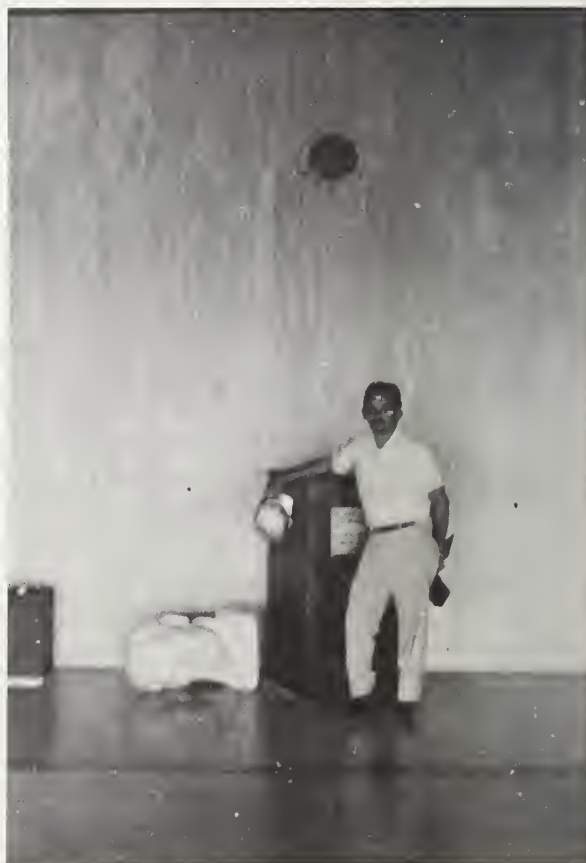
Figure 41-4 Fallen bust of Ruben Dario, Ing. Raul Amador of Nicaraguan Ministry of Public Works, Teatro Ruben Dario.

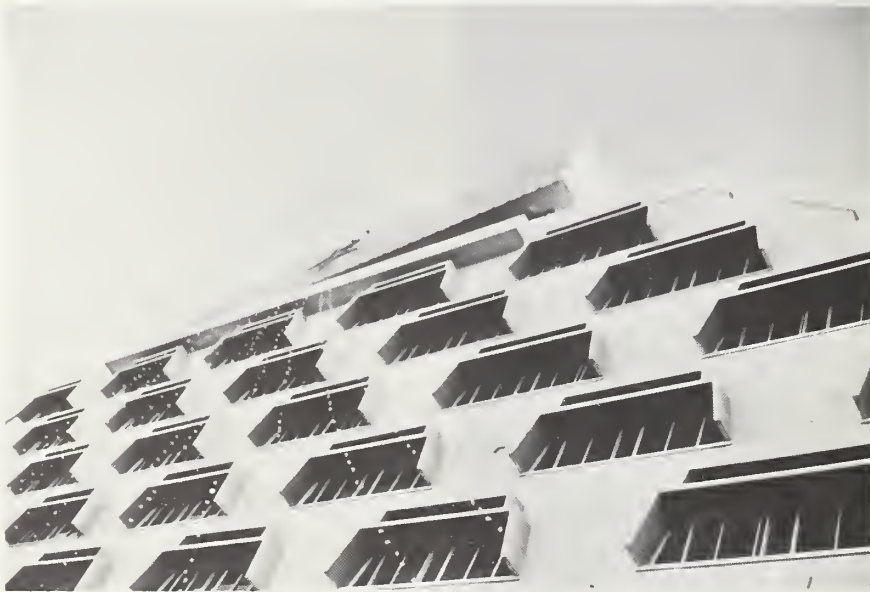
The structure is a moment resisting concrete frame, figure 42-1. Preliminary investigation revealed two failed columns in the first floor. The columns carrying the mechanical penthouse also have failed, figures 42-2 and 42-3. It is recommended that:

Figure 42-2 Minor facade cracking and displacement of mechanical penthouse, Hotel Intercontinental.

- A. All beam-column connections (currently covered by architectural details) be inspected.
- B. The building reanalyzed before repairs for ground motion 1.5 times that measured at the Esso refinery or for ground motion resulting from a site study.

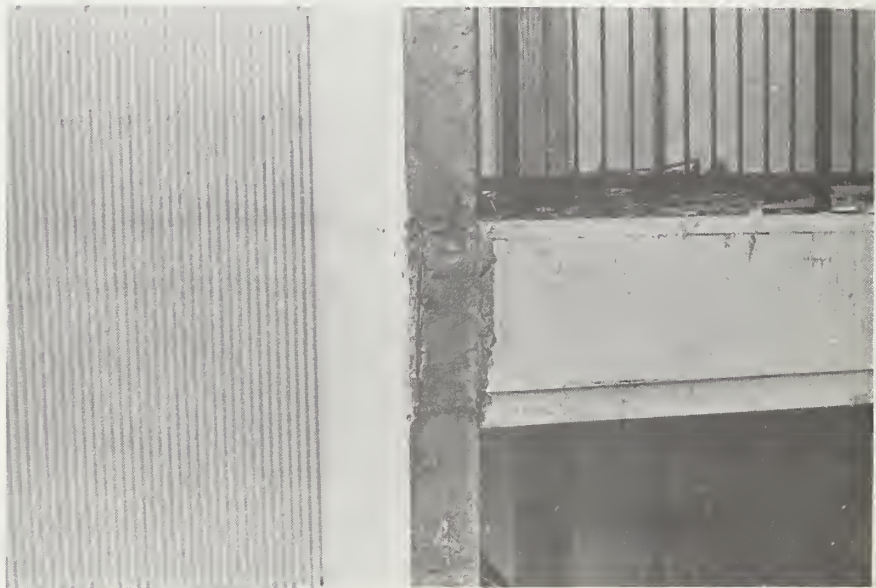
Figure 43-5 Damage to shear walls at first floor
level, Corte Suprema de Justicia.

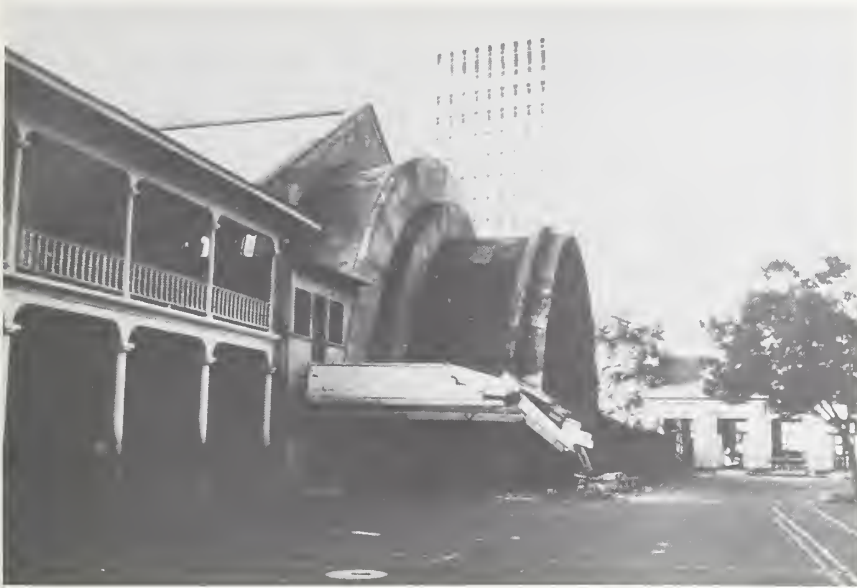
Figure 46-1 Old building and chapel of the Instituto Pedagógico.
